Name Of Dam: SPRING VALLEY LAKE  
Location: CITY OF ROANOKE, VIRGINIA  
Inventory Number: VA 77002

## PHASE I INSPECTION REPORT NATIONAL DAM SAFETY PROGRAM

NOVEMBER 1980

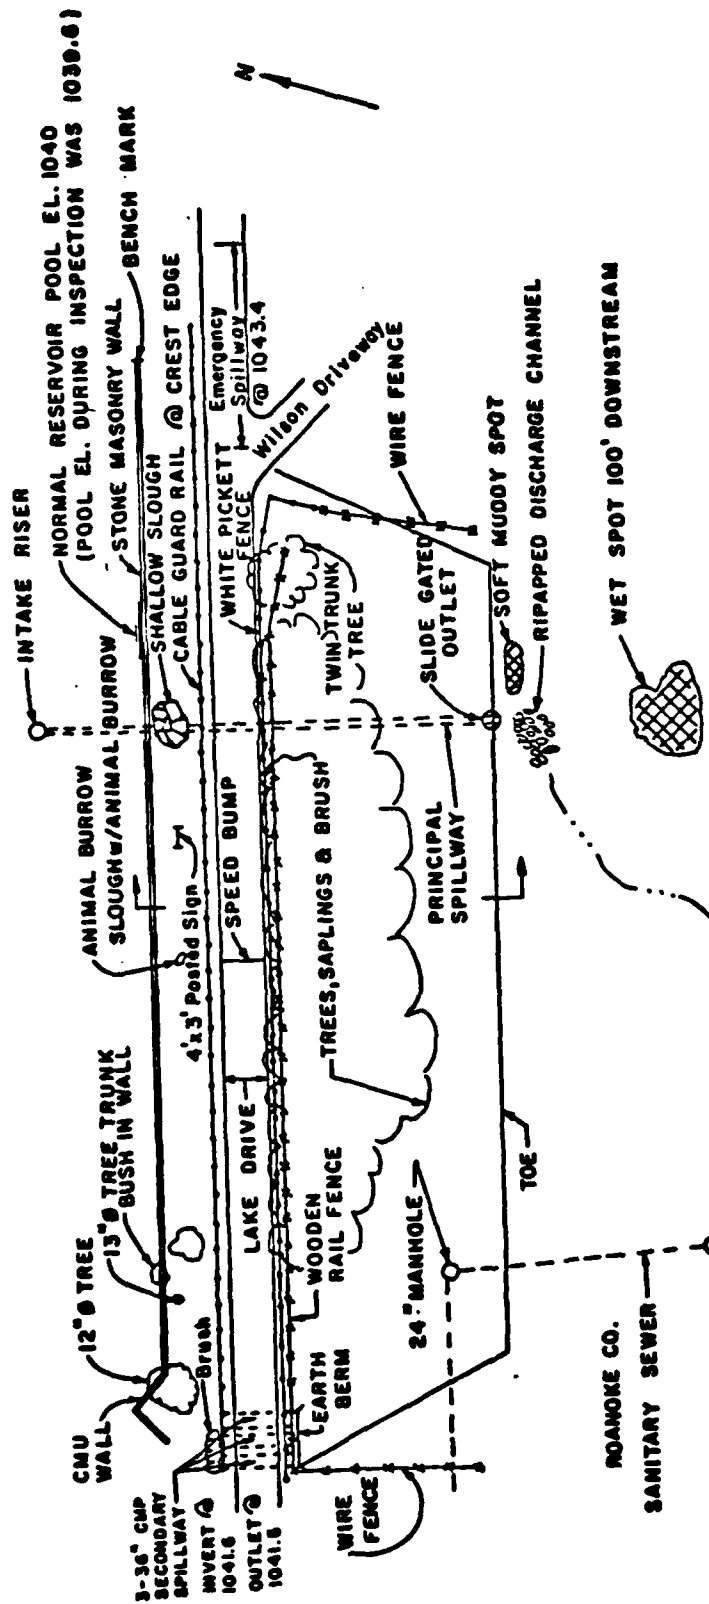
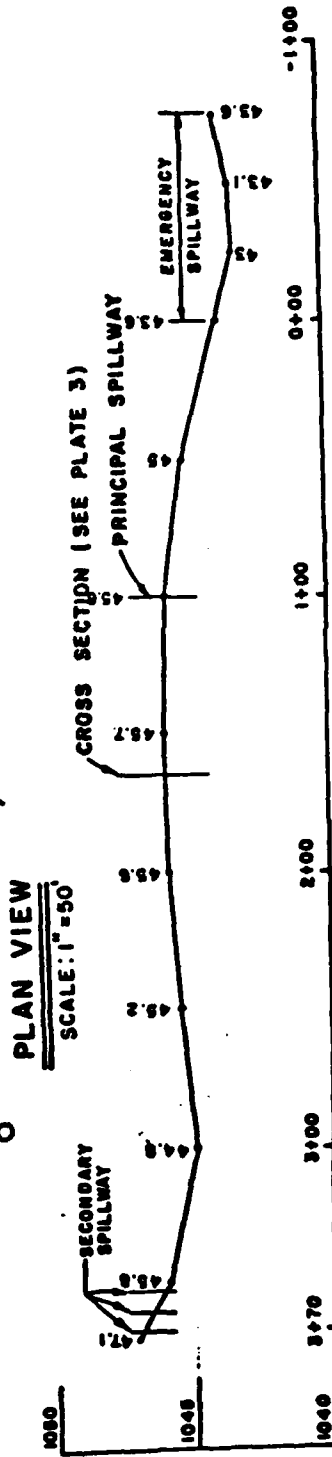
PLATE II

The upstream slope is covered with trimmed grass. Also, there are three trees and some brush on the slope as located on Plate II, Appendix I. The downstream slope is sparsely vegetated with grass. Portions of the slope are vegetated with bushes, saplings, and trees as shown in Photo. No. 3, Appendix II. The immediate downstream area is a fenced horse pasture area and the animals graze on the downstream slope.
